USAAVLABS TECHNICAL REPORT 68-65

ADVANCEMENT OF HIGH-TEMPERATURE TURBINE TECHNOLOGY FOR SMALL GAS TURBINE ENGINES

FLUID-COOLED AXIAL FLOW TURBINE

Continental Report No. 1094

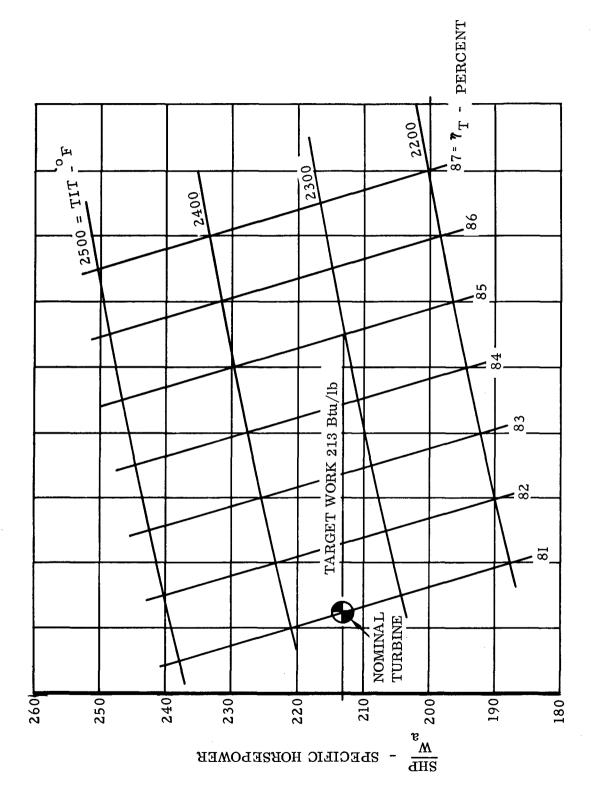
Figure 3. Effect of Turbine Inlet Temperature and Turbine Efficiency on Specific Horsepower.

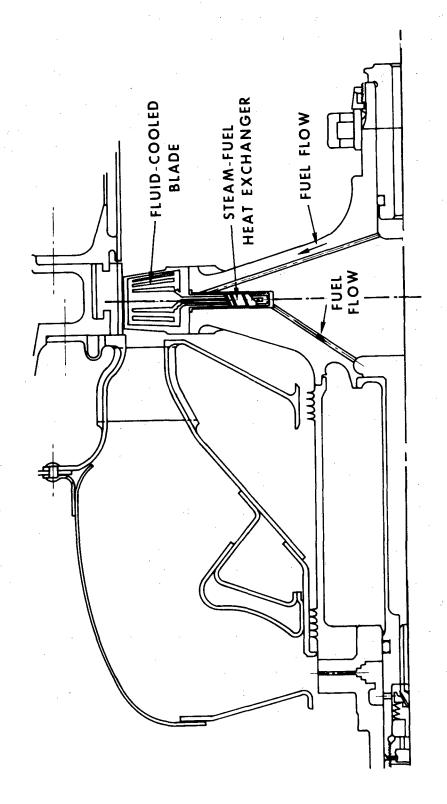
Figure 6. Cooling System for Fluid-Cooled Turbine Blade.

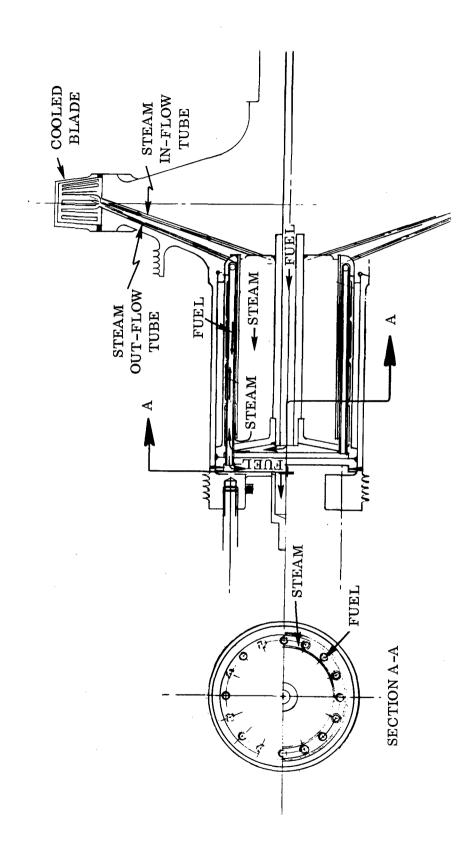
Figure 7. Cast-Cored Wheel With Heat Exchanger in Engine Shaft.

Electron beam welding techniques have been established for individual blade blocks simulating the attachment. For the heat exchanger in disc configuration, the temperature gradient causes an unacceptable rim crushing load. For the heat exchanger in the shaft, welding might be considered as a blade attachment technique or as a low-ductility cast hub replacement.

Electron beam welding was not selected because consistent reproducible welding of over 30 blades into a disc in these materials is not considered to be feasible at present, and because experienced shrinkage in 30 to 60 welds around the periphery of a disc is considered to be a problem not amenable to ready solution.

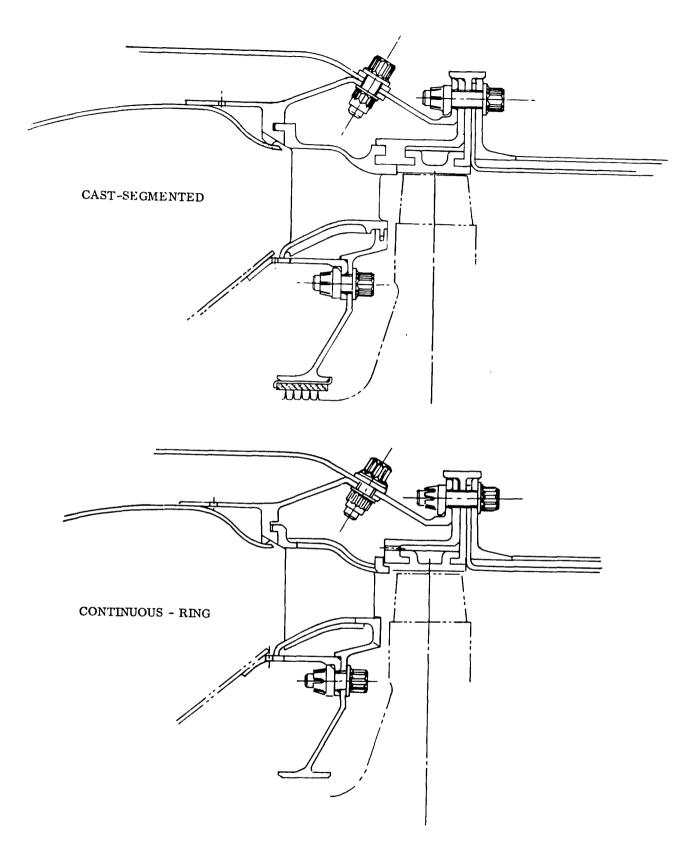
Figure 8. Cast-Segmented and Continuous-Ring Turbine Inlet Nozzle.

The internal finned vane with trailing-edge cooling slots was selected and built into a cascade test specimen. The specimen was instrumented to measure metal temperatures and flow conditions and was tested at nonregenerative conditions for 17.5 hours; 3.5 were at over 2000°F turbine inlet gas temperature.

The highest vane temperature measured was 1470°F at a mean turbine inlet temperature of 2403°F. Results confirm the general level of vane temperatures computed, with measured vane temperature distribution being more uniform than predicted. Shroud temperatures were found to be lower than predicted.

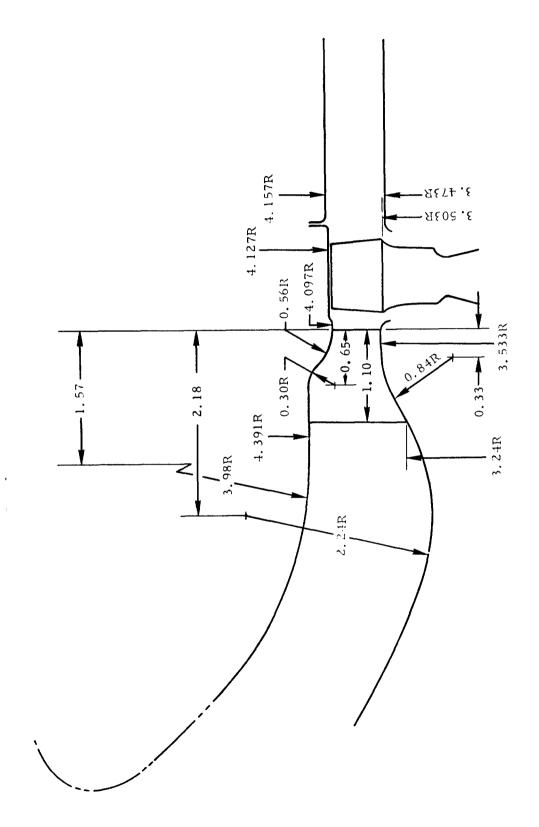
Figure 27. Fluid-Cooled Turbine Flow Path for Cold Flow Rig Testing, 23 Nozzle Vanes.

The high-temperature turbine is assumed to be driving a two-stage centrifugal compressor, developing a pressure ratio of 9.2 at an efficiency of 79.5 percent. As determined during preliminary design, the compressor aerodynamics of a practical machine would demand a rotative speed of about 50,000 rpm. Fixing the speed, work, and flow requirements greatly narrows the choice of parameters affecting the efficiency of a single-stage turbine. Further restrictions are imposed by considerations of stress, degree of reaction, Mach number levels, blade turning angles, blade solidities, and physical geometry. The effects of parameter variation were investigated by means of semiempirical techniques on an IBM 1620 digital computer. The flow path evolved from this study is shown in Figure 27.

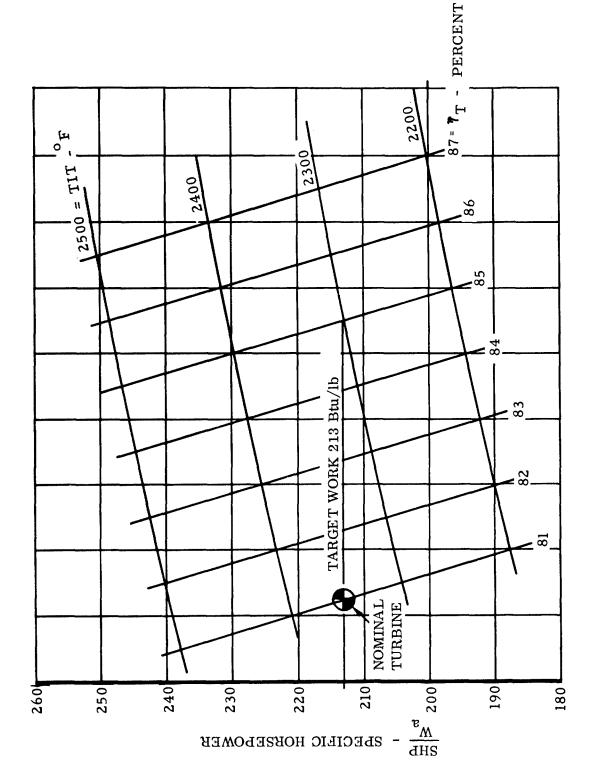
Figure 50. Effect of Turbine Inlet Temperature and Turbine Efficiency on Specific Horsepower.

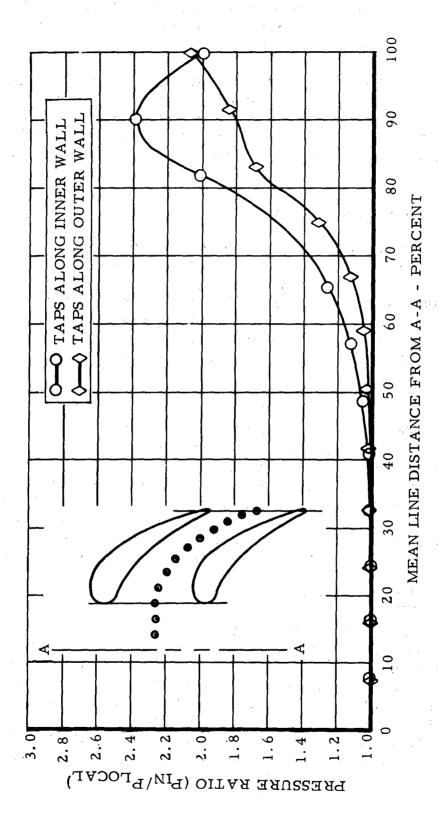
Figure 55. Nozzle Pressure Characteristics - 23 Vanes Set Nominally.

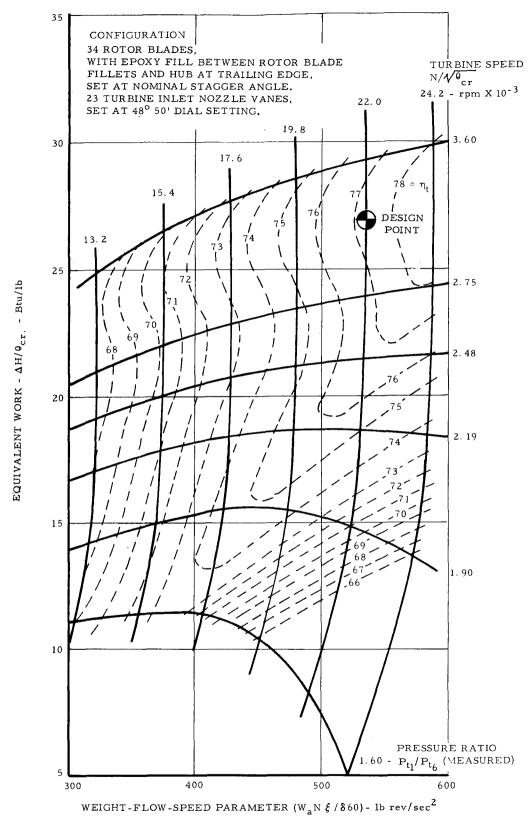
Figure 56. Fluid-Cooled Turbine - Test Stand Performance.

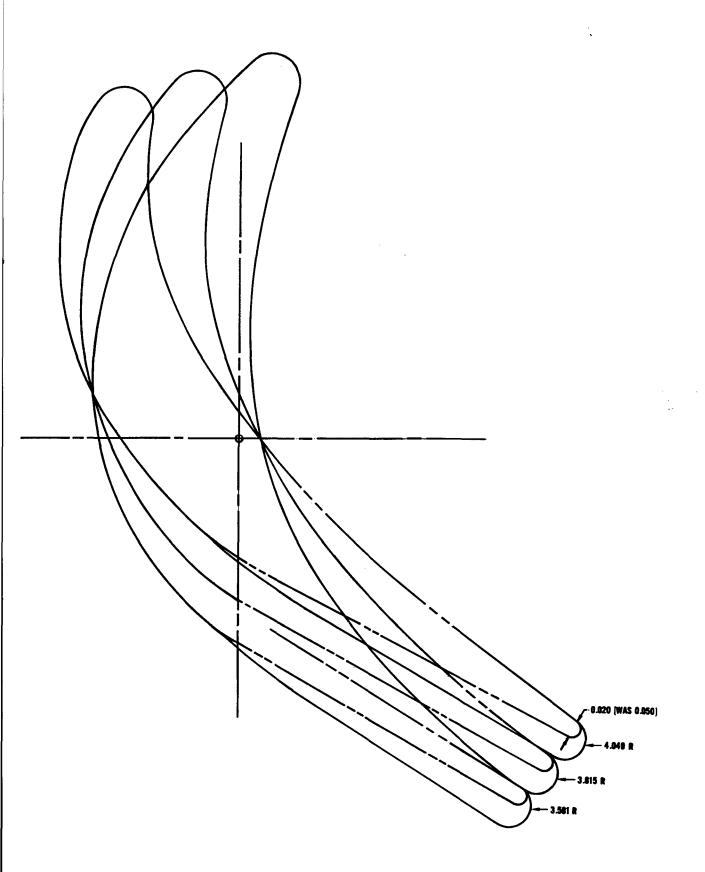
Figure 66. Modified Fluid-Cooled Blade Sections.

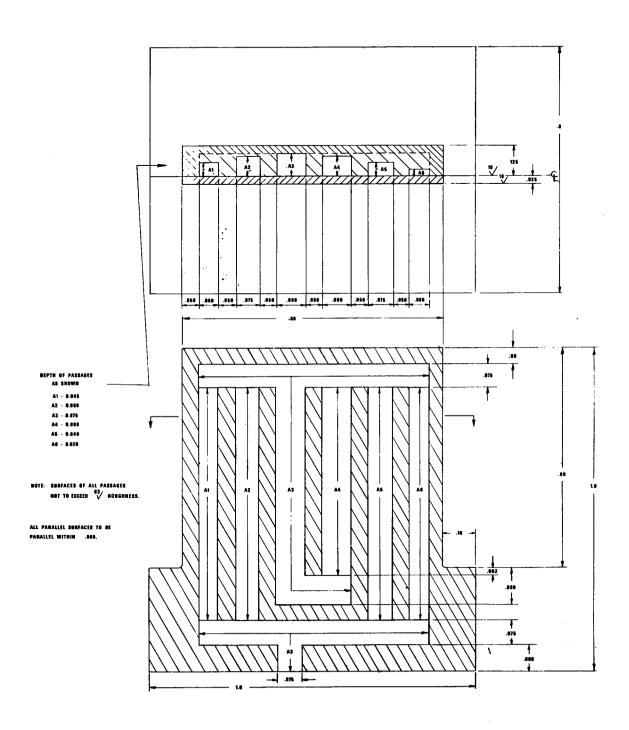
Figure 70. Cross Section of Preliminary Rectangular Blade.

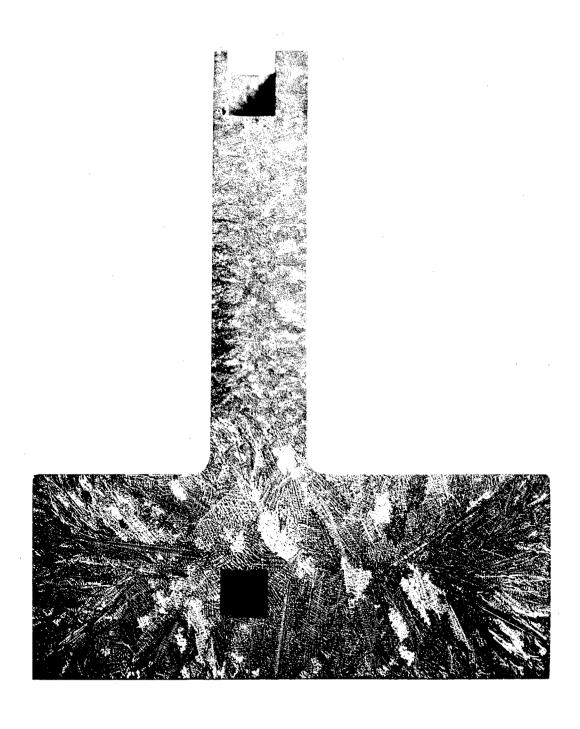
Figure 78. Macro-Etched Cross Section Showing Grain Structure.

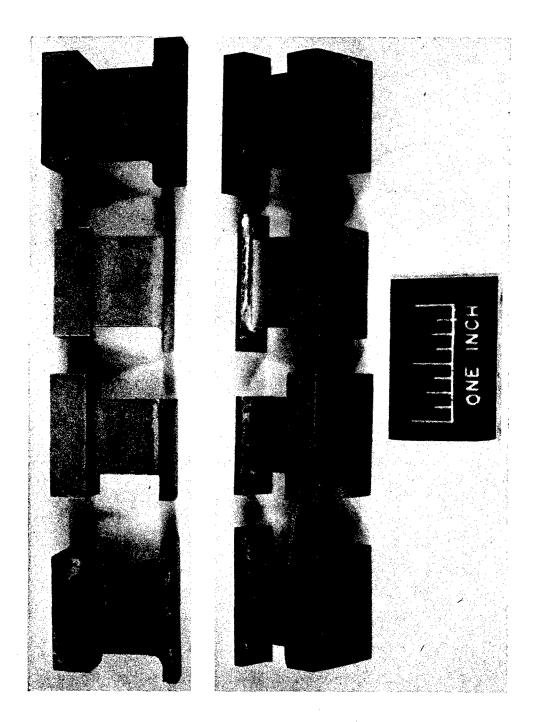
Figure 100. Rectangular Castings With EDM Tip-Caps.

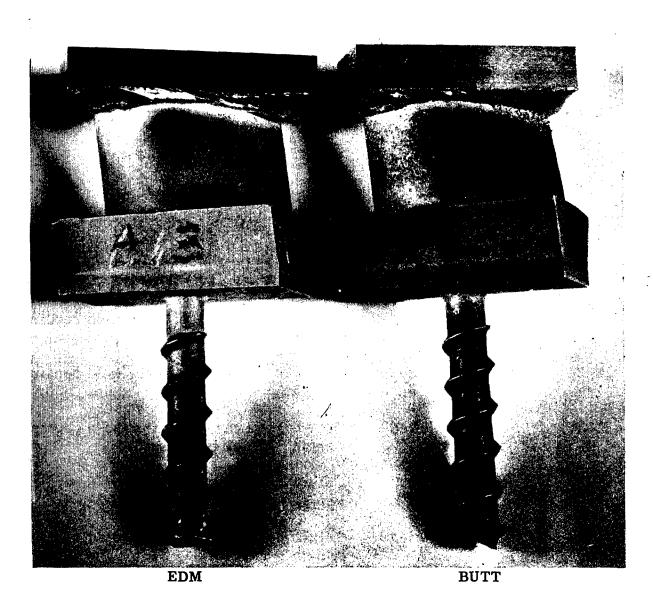
Figure 110. Beam Welded Airfoil Cap.

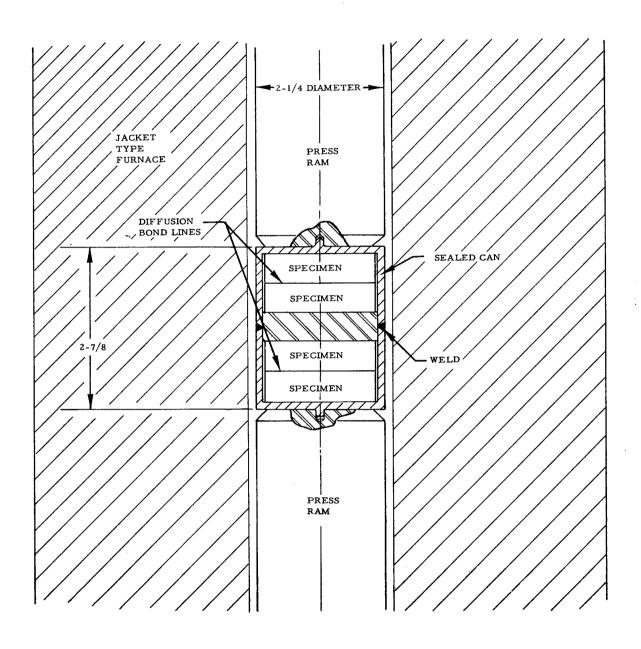
Figure 140. Tooling for Pressure Bonding of U-700 Grooved Blocks.

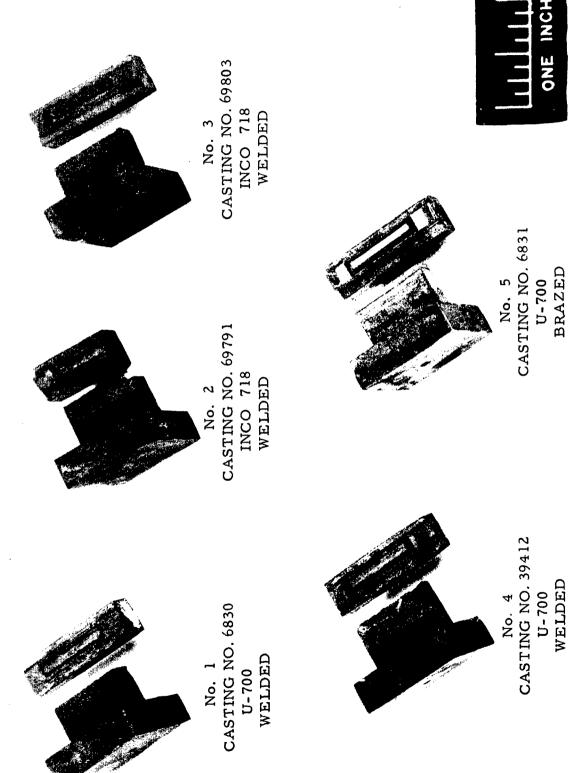
Figure 156. Pull Test on Blade Caps.

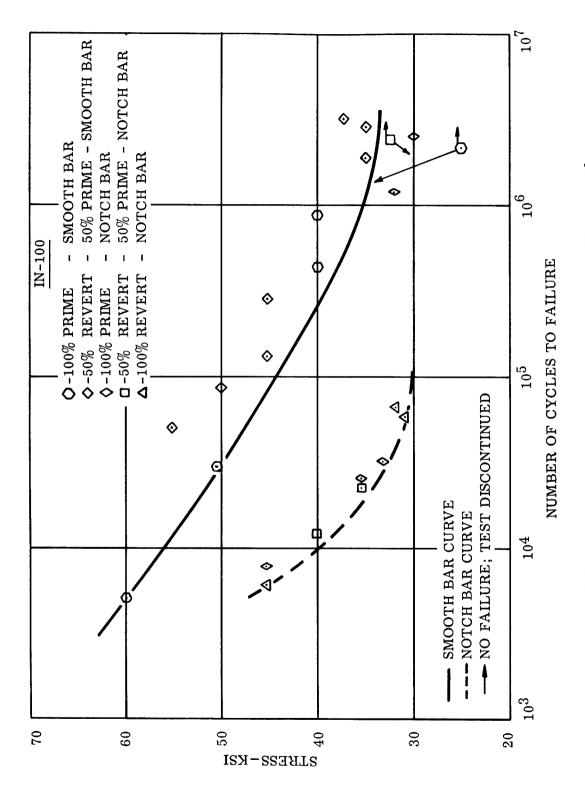
Figure 163. Mechanical Fatigue Results for IN-100 at 1700°F.

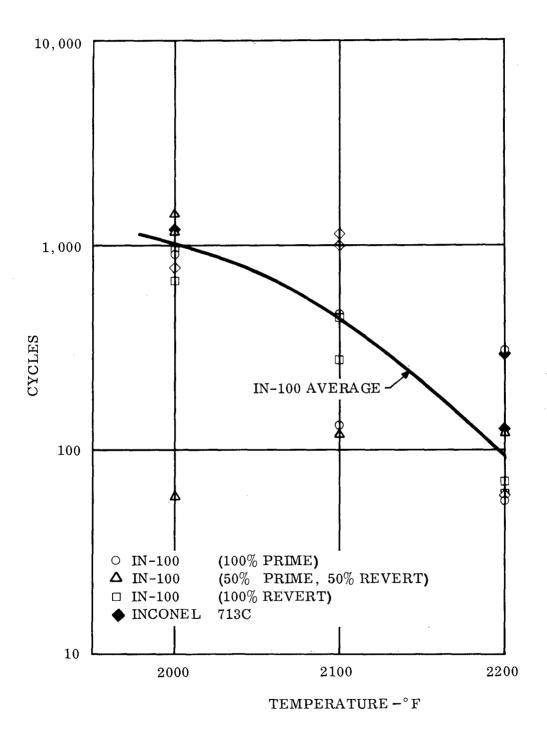
Figure 164. IN-100 - Thermal Fatigue Cycles to Initial Cracking.

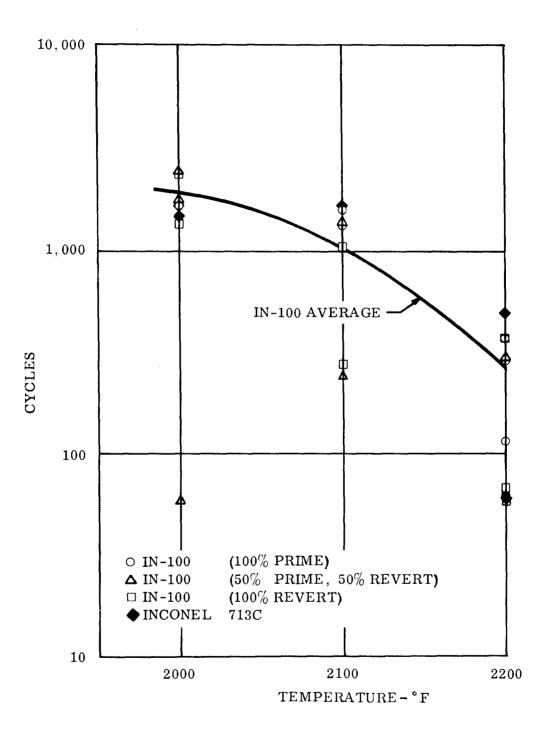
Figure 165. IN-100 - Thermal Fatigue Cycles to Failure.

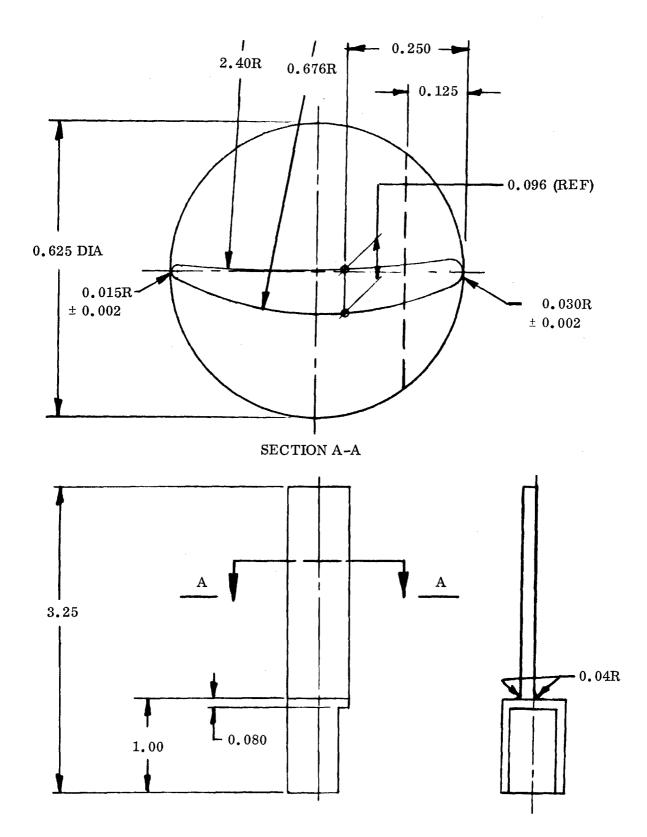
Figure 166. Thermal Shock Blade Specimen.

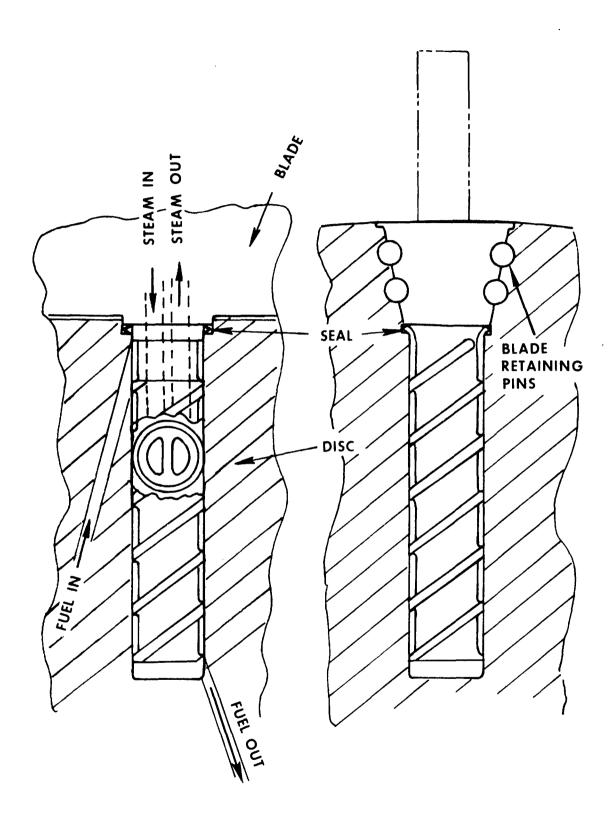
Figure 169. Fin Steam to Fuel Heat Exchanger.

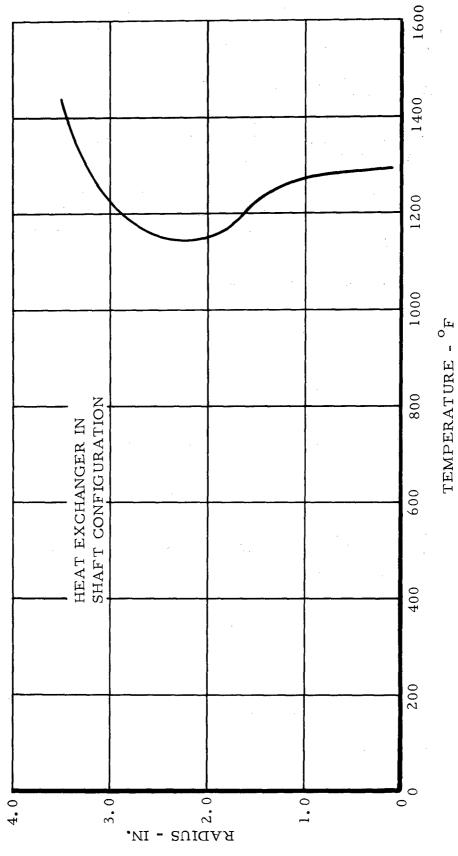
Figure 173. Turbine Rotor Shaft Radial Temperature Distribution.

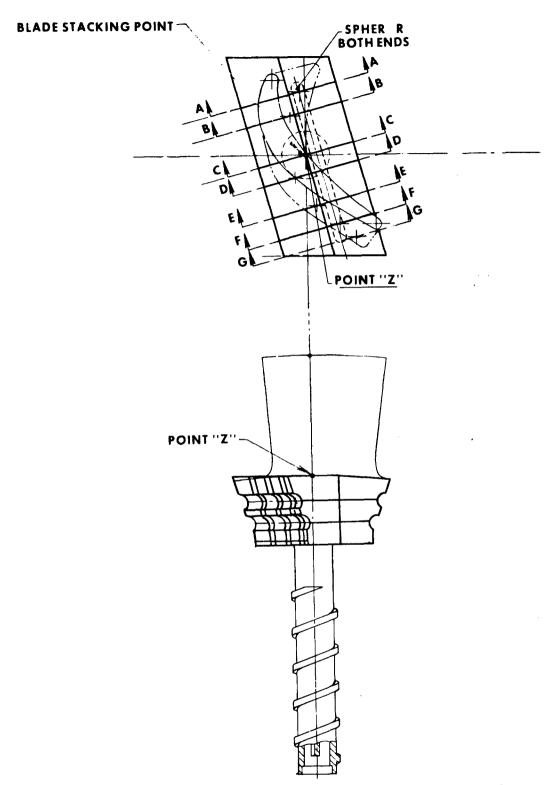
Figure 178. Blade Attachment Sectioning for Heat Transfer.

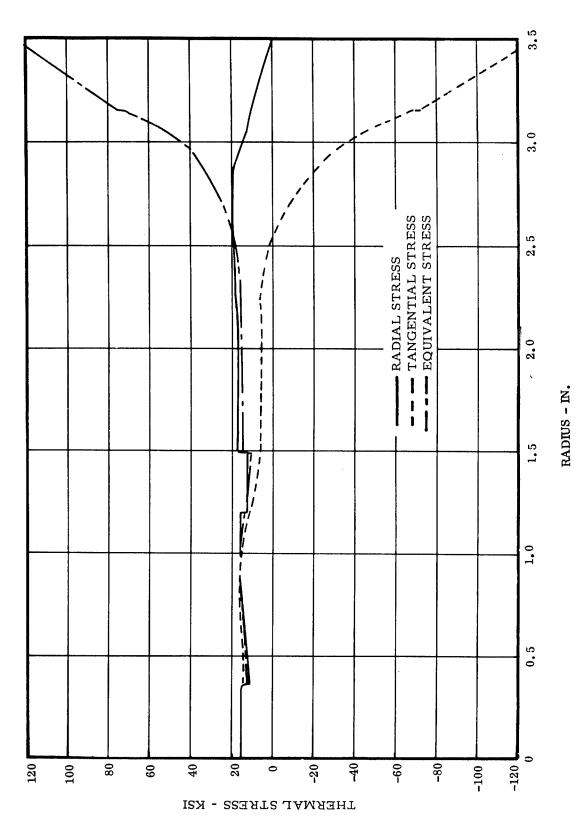
Figure 199. Turbine Rotor Disc With Welded Attachment - Thermal Stresses at Shutdown (RPM = 0).

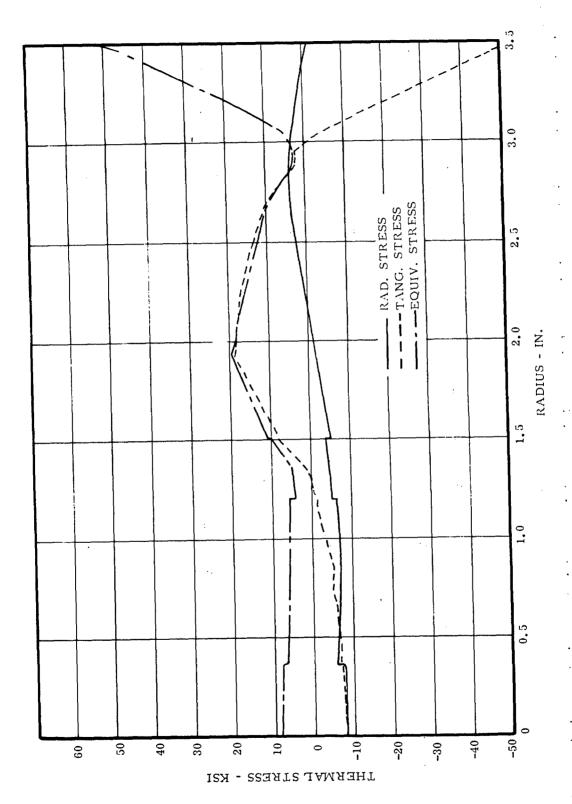
Figure 205. Integral Cast Turbine Rotor Disc - Thermal Stresses at Shutdown (RPM - 0).

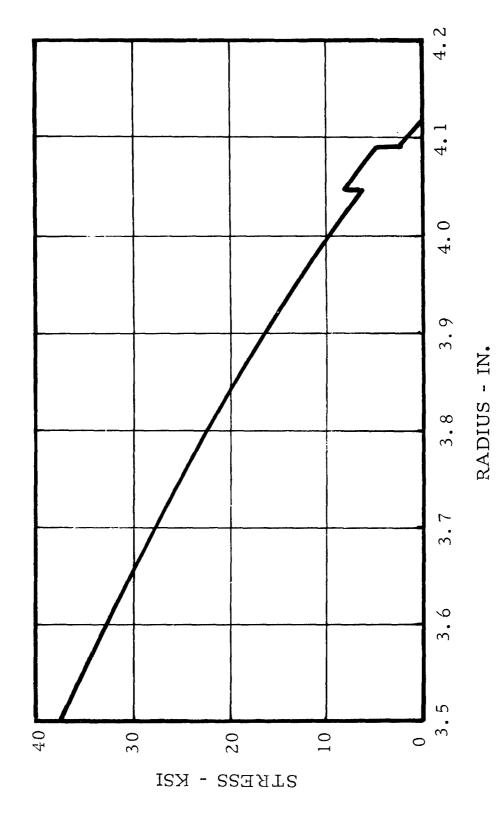
Figure 208. Blade Stresses Due to Centrifugal Loading Only - Unmodified Blade Core.

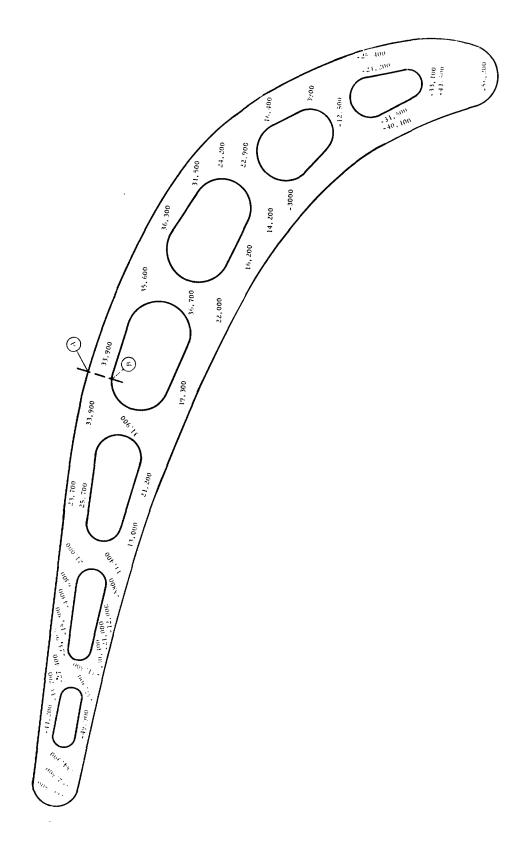
Figure 210. Fluid-Cooled Turbine Rotor Blade Thermal Stress Distribution, Mid-Span Section.

Thermal Stresses. The blade temperature stresses were computed by means of Continental Program No. 02.008. The mid-span temperature distribution is given in Figure 207, and the stresses in Figure 210. It should be pointed out that these stresses are approximate, since the span is very short compared to the chord length. The analysis used in the computer program assumes that end conditions do not affect the results (St. Venant's principle) and is only true when the section analyzed occurs at least one chord length away from the end. These blades have a span less than the chord, which invalidates the exactness of the results:

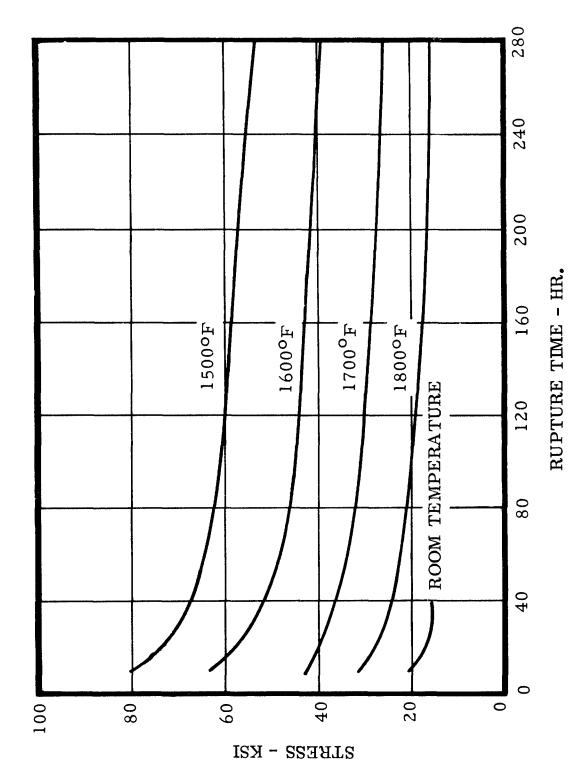
Figure 211. Stress-Rupture Properties - Cast U-700.

- 1b. Airfoil Root at Trailing Edge. At this location the mechanical tensile inertia and steam pressure stresses are counterbalanced by the compressive thermal stresses. During operation, the maximum stress point will occur at the inner surface of the trailing edge cooling duct. Resultant stress will be between 4300 psi and 25,000 psi at 1660°F, depending on wall thickness. Stress-rupture life in excess of 300 hours will be obtained.

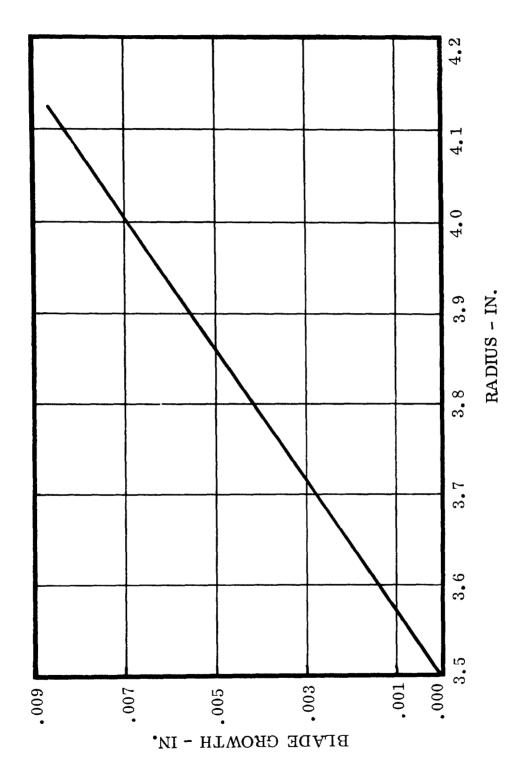
Figure 212. Turbine Rotor Blade - Radial Blade Growth.

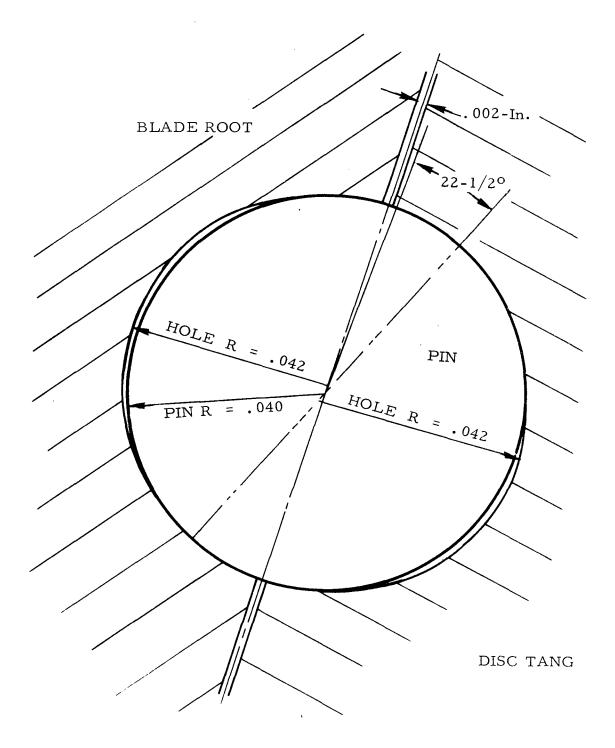
Figure 213. Pin Detail.

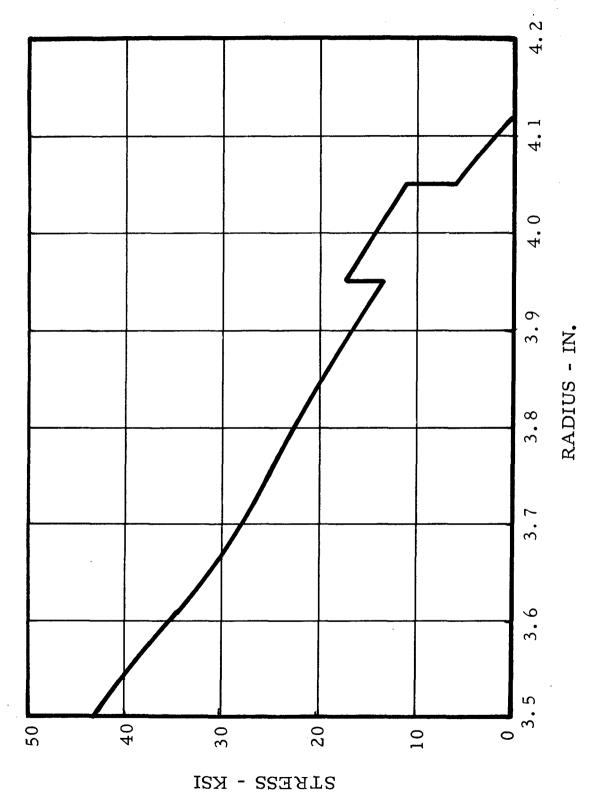
Figure 214. Blade Stresses Due to Centrifugal Loading Only - Modified Blade Core.

It was shown that the remaining thermal stresses will be counterbalanced by the inertia and steam pressure stresses and that the life of the airfoil is about 300 hours.

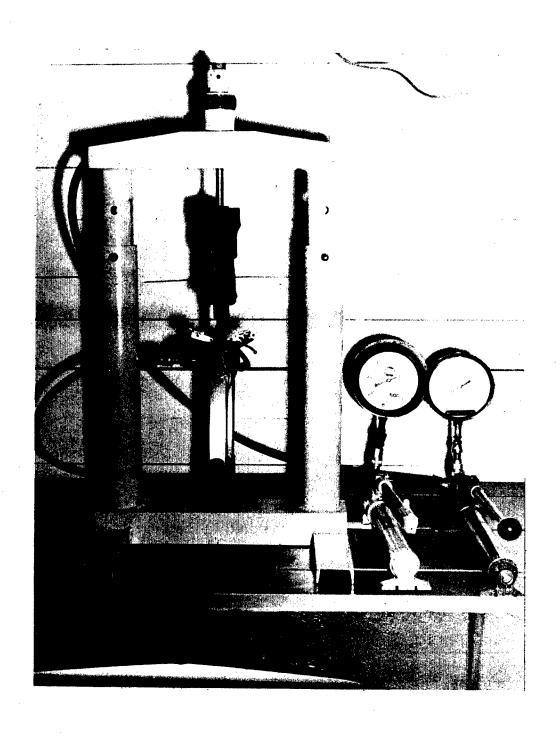
Figure 217. Blade-to-Disc Pinned Attachment Test Fixture With Hydraulic Loading Mechanisms and Dial Indicators.

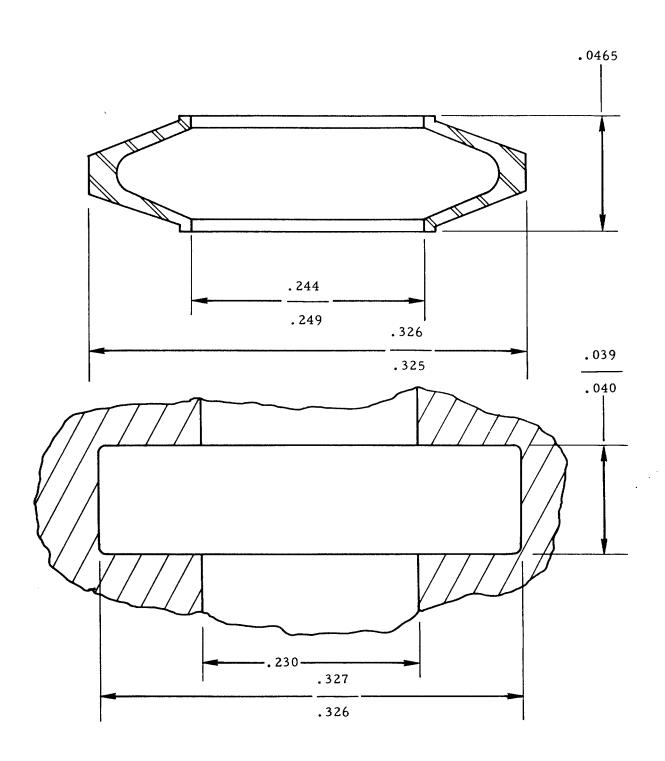
Figure 226. Metal "V" Seal - Revised.

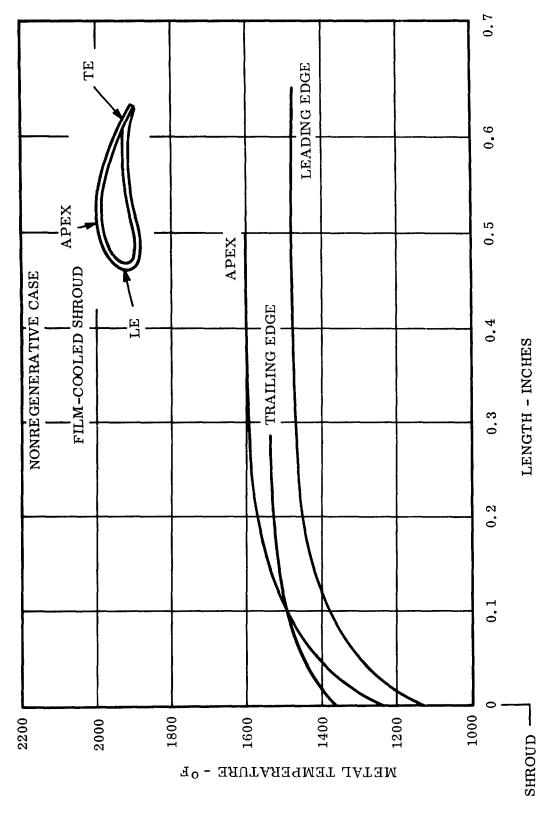
Figure 250. Nozzle Vane Radial Temperature Distribution - Nonregenerative Case.

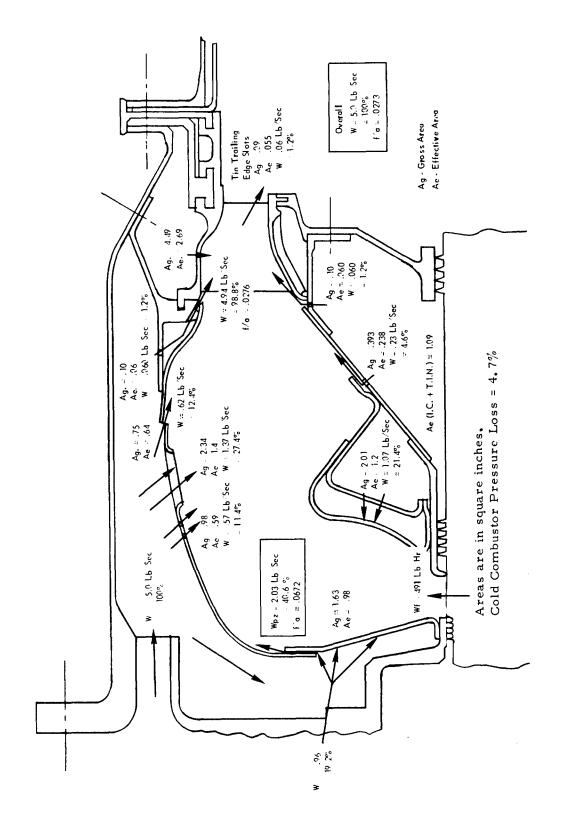
Figure 255. Nonregenerative Cycle - Combustor Airflow and Port Area Distribution.

Port areas and airflow distribution of the combustor were determined for the nonregenerative cycle conditions and then applied to the regenerative cycle conditions. The calculated combustor airflow distribution provides for a stoichiometric fuel-air ratio in the primary zone for the nonregenerative cycle. This is accomplished by a proper ratio of primary zone port areas (swirl vane plus inner combustor) to secondary, or mixing, zone port areas. This same primary-to-secondary flow area ratio provides a regenerative cycle primary fuel-air ratio of 0.0464. Airflow and port areas distribution are indicated on Figures 255 and 256 for the nonregenerative and regenerative cycles, respectively.

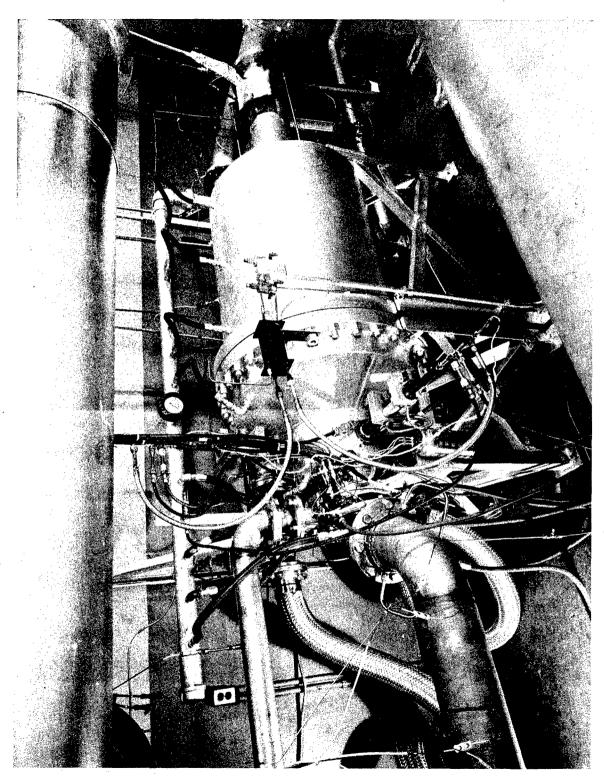
Figure 257. Turbine Inlet Nozzle Hot Cascade Rig.

The cascade tested consisted of a brazed TD nickel turbine inlet nozzle segment of three vanes and four flow passages. This configuration was chosen to eliminate sidewall effects on the central, instrumented vane, thus closely simulating actual engine flow conditions.

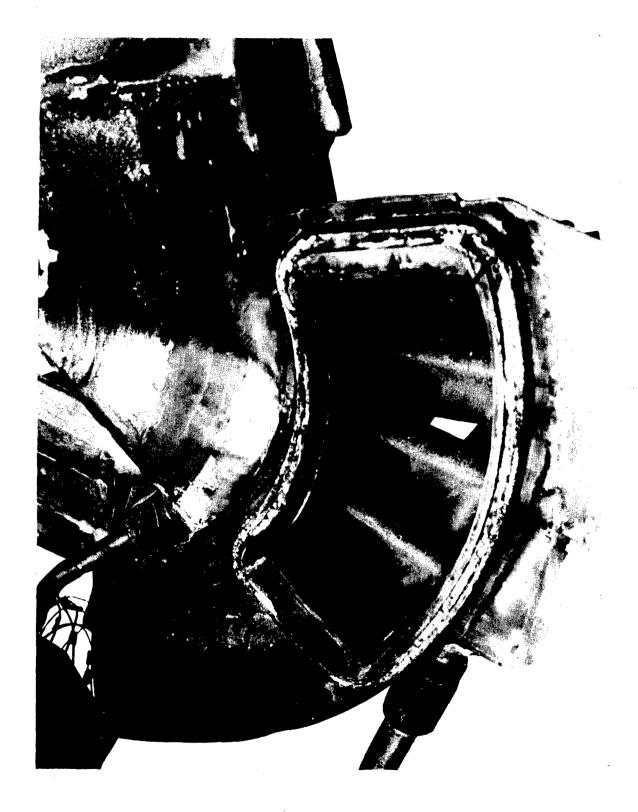
Figure 291. Turbine Inlet Nozzle Cascade After Test - View of Inner Shroud.

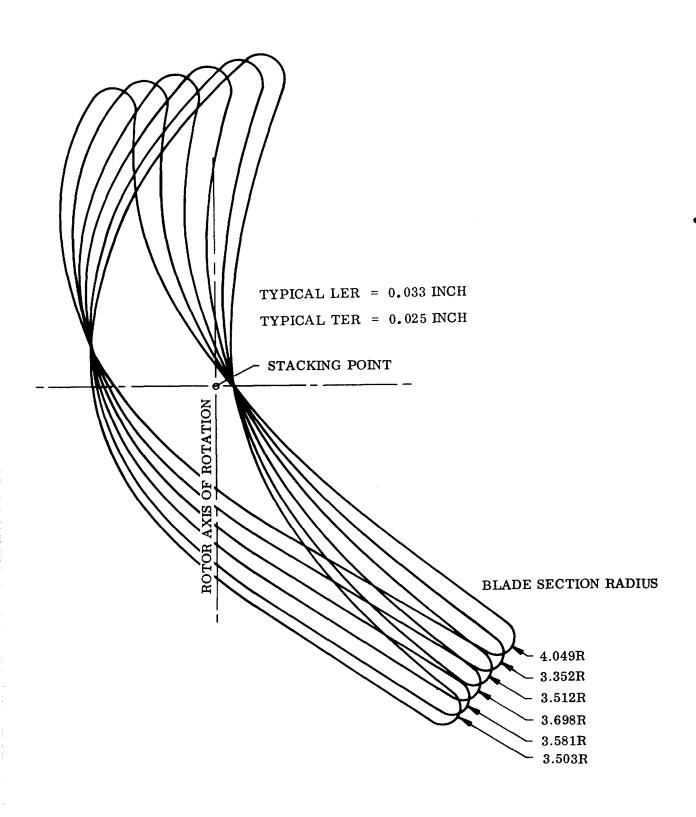
Figure 297. Fluid-Cooled Rotor - 34 Blades.

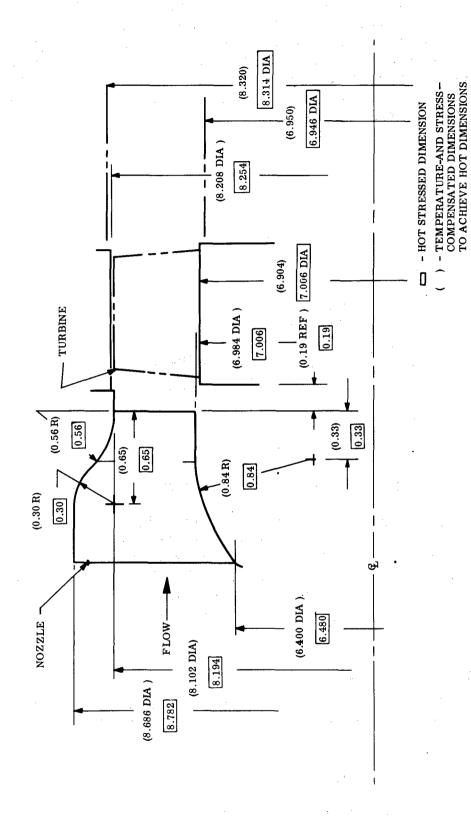
Figure 298. Nozzle/Turbine Dimensional Variation Due to Thermal and Stress Compensation.

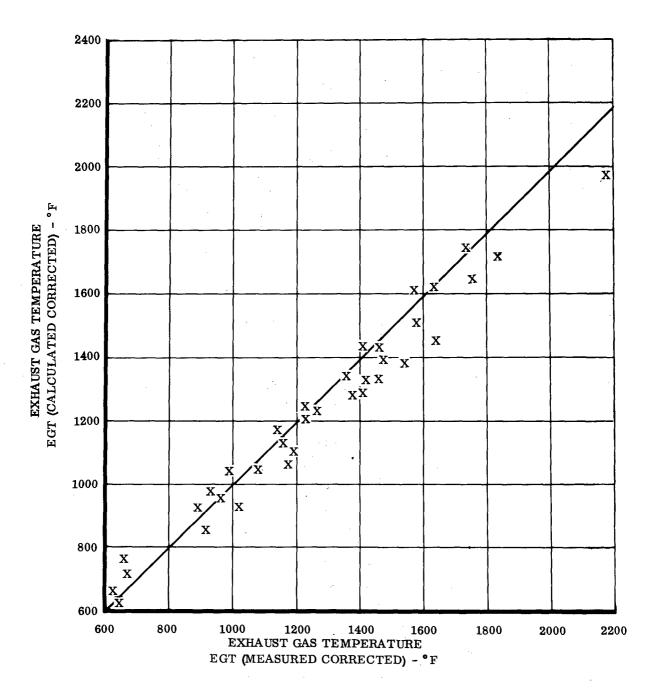
Figure 301. Exhaust Gas Temperature - Corrected.

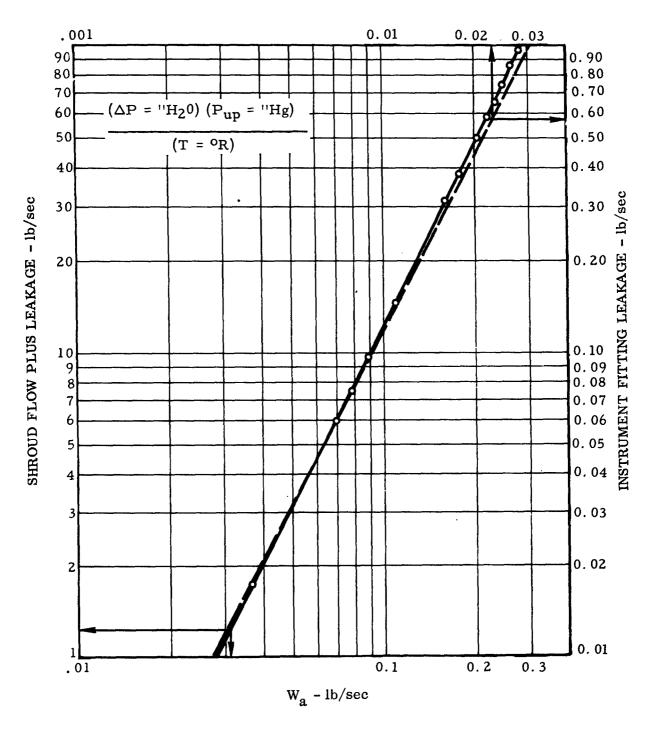
Figure 302. Shroud Cooling Flow and Leakage.

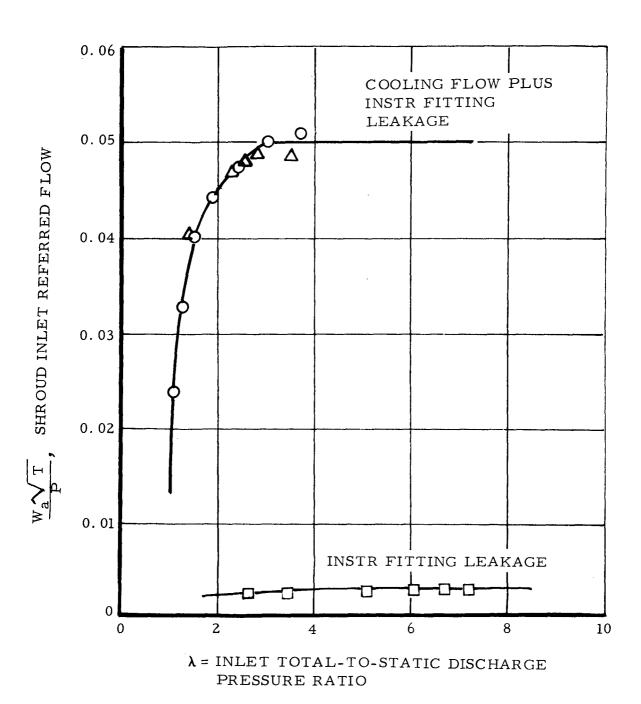
Figure 303. Shroud Inlet Referred Flow Versus Pressure Ratio.

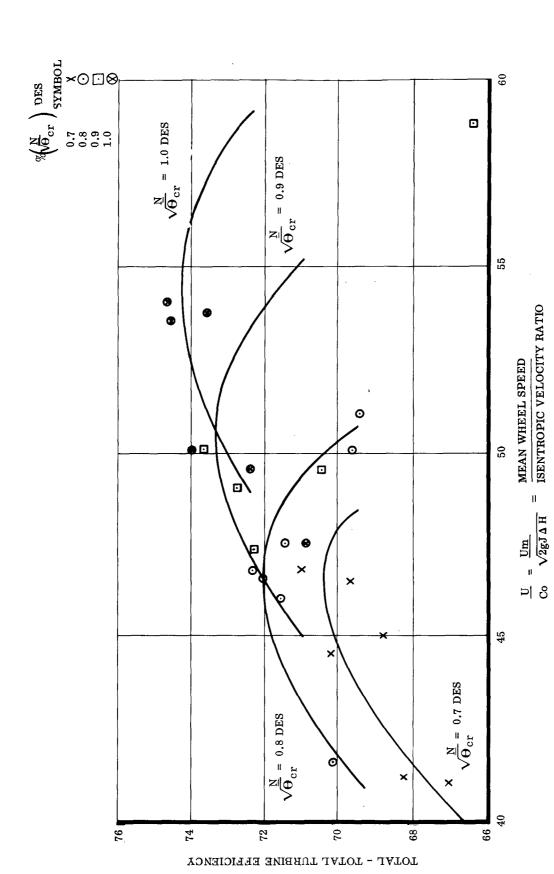
Figure 306. Mean Wheel Speed Versus Turbine Efficiency.

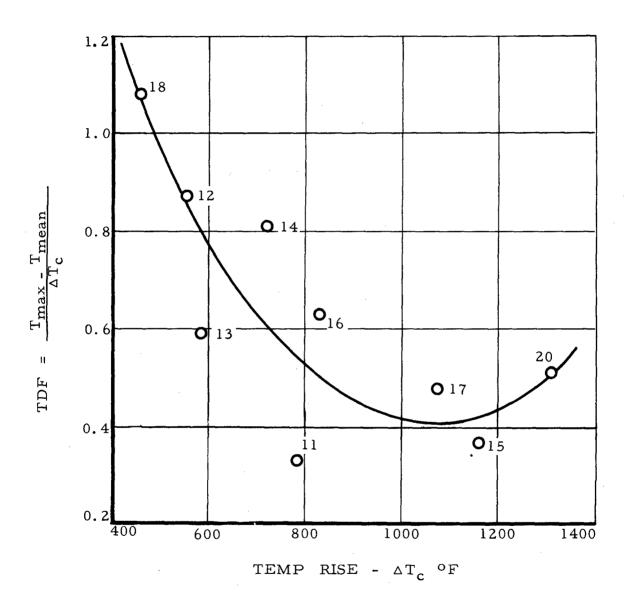
Figure 310. Temperature Distribution Factor Versus Temperature Rise - Combustor Build 2.

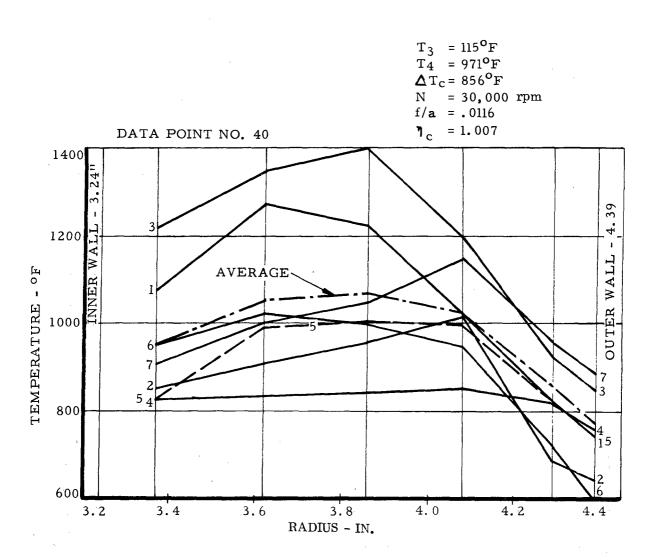
Figure 322. Combustor Exit Radial Temperature Profile.

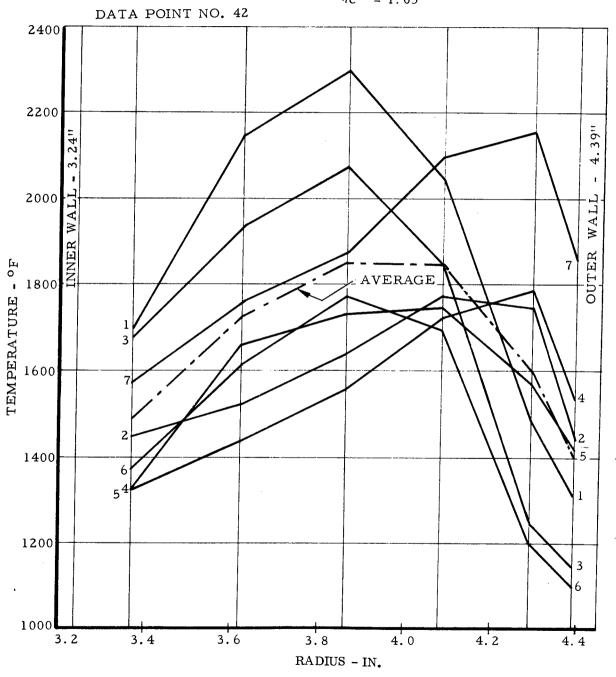
Figure 324. Combustor Exit Radial Temperature Profile.

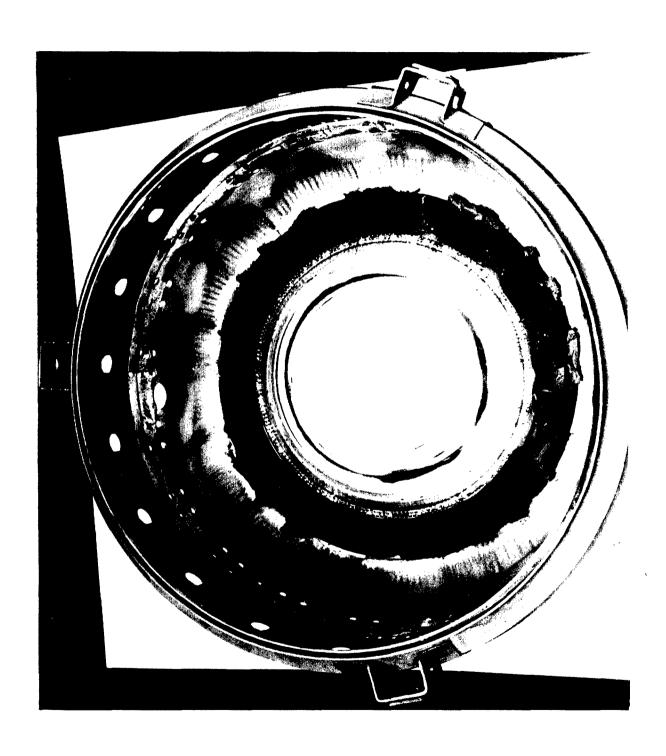
Figure 362. Carbon Buildup on Swirl Plate After Build 6 Testing - Turbine Rig.
